Seat Base Swivel Troubleshooting Guide (All models)

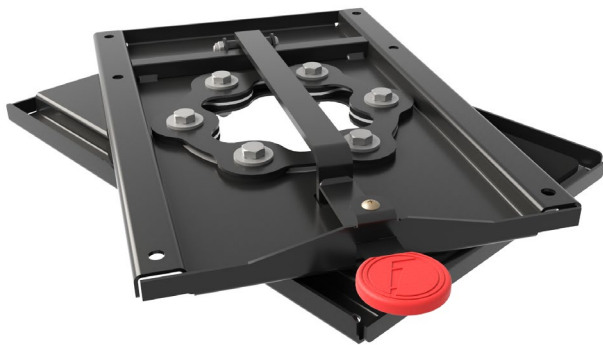
Figure 1
Swivel Top View

Issue: Swivel tight to turn once installed into vehicle.

Cause: If the swivel is hard to turn once installed into the vehicle, it is most likely because the 6 main **M10 centre bolts** that hold the swivel together (**Fig. 1 & Fig. 2**) have been overtightened during the initial assembly or installation processes.

Solution: Loosen the **6 x M10 bolts/nyloc nuts**, ensure the swivel turns freely, then retighten them to **4.4Nm**. If a torque wrench isn't available, tighten the **nyloc nuts** just enough until all **12 washers** (6 x top and 6 x bottom) don't have any movement.

Note: *The seat may need to be removed from the swivel to allow access to the bolts/nuts.*
